Helping Floodville

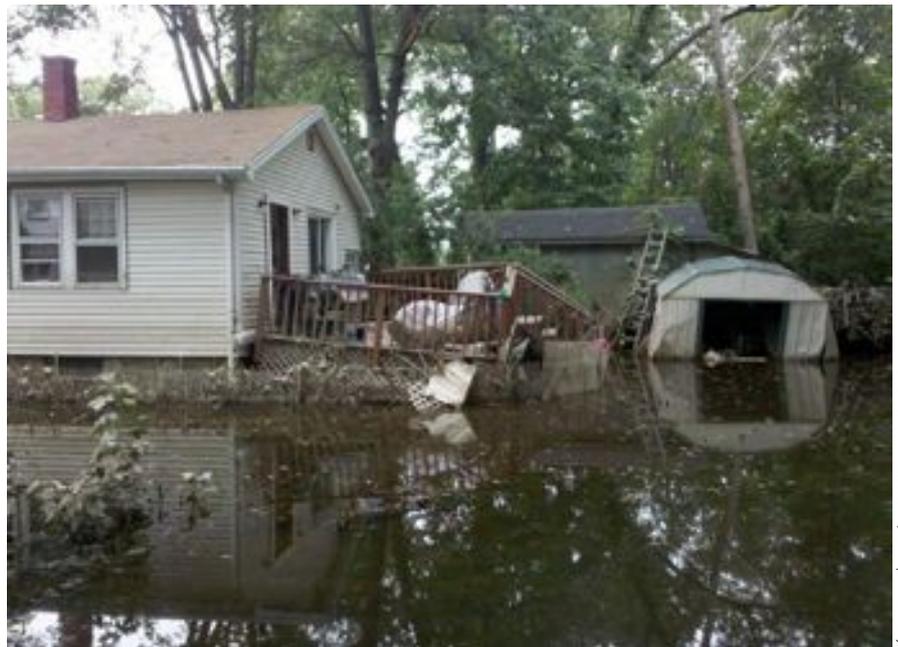
G.C. Stewart Associates, Inc. (9/5/2011)

Tropical Storm Lee hit New Jersey less than a week after Hurricane Irene left town late August 2011, and the cumulative 20-plus inches of rain made life even more miserable for homeowners already applying for buyouts. Stains on the house siding show the most recent height of floodwaters.
